STREAM GRADIENT CHANGES OF DRY CREEK
AS INDICATED BY FLOODPLAIN GRADIENTS

A senior thesis submitted to fulfill
the requirements for the degree of
B.S. in Geology, 1984
at
The Ohio State University

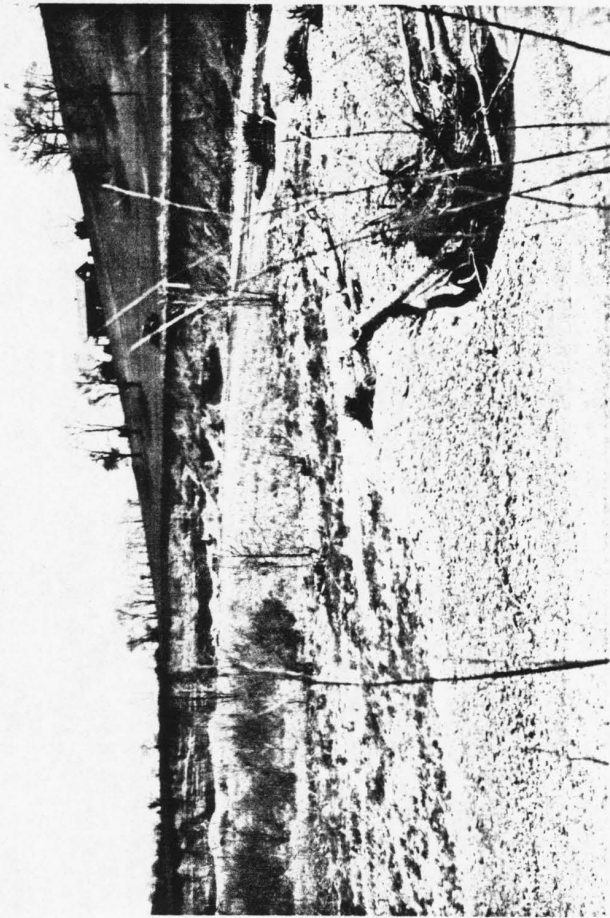
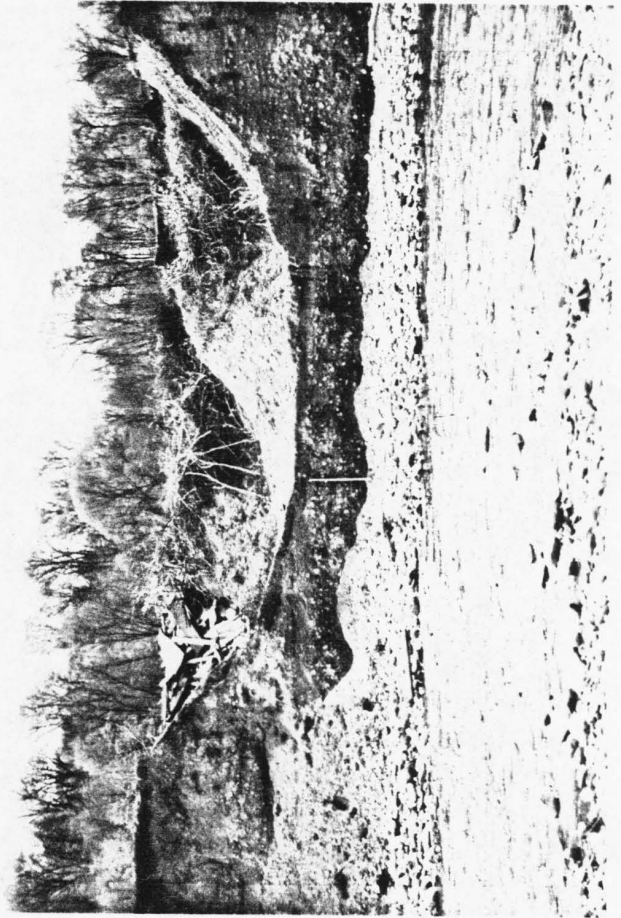
Figure 4. Progressive degradation on the "Big Bend". a. View south-east from western part of bend. b. View east from south edge of the bend. c. View to south of drainage cut. Jacob's staff is 5 feet tall.

Historical Background. Dry Creek is a third order, ephemeral, gravel bed stream located 6.4 kilometers north of Newark in Licking County, Ohio (Figure 1,2, and 3). Progressive upstream degradation has eroded over two acres of land around the "Big Bend" on the Finney Farm (Figure 4) and has formed floodplain terraces on the accreting point-bar (Figure 5). A study of aerial photographs indicates that degradation has progressed upstream since the start of sand and gravel mining in 1945 and rapid migration of the "Big Bend", 2 kilometers from the mouth of the stream, has occurred since the early 1960's.

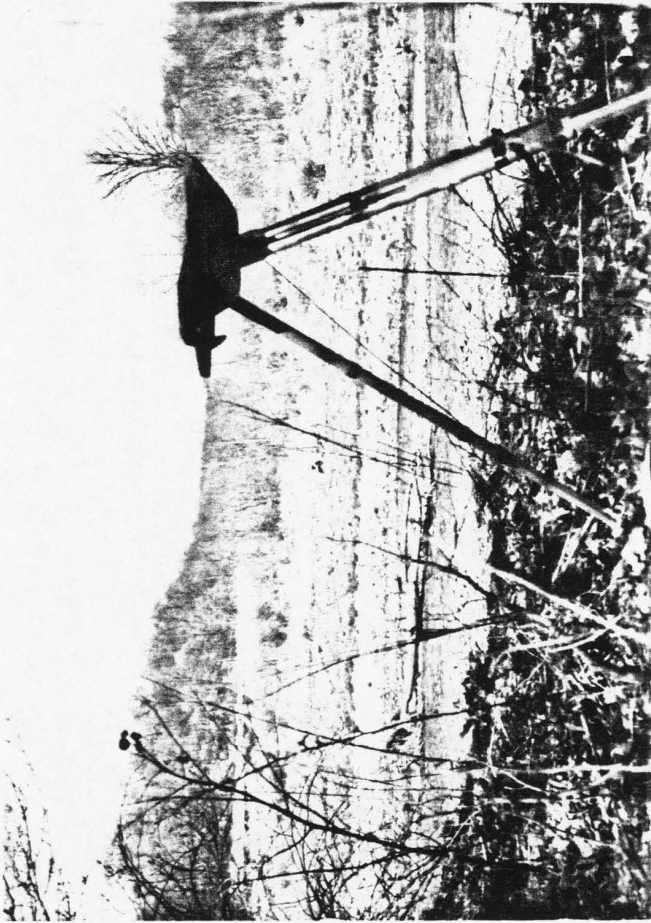
Figure 12. Plane Table . The table is centered over a reference point and oriented to the compass directions. Surveying is done with the aid of an alidade (not shown), and the stadia rod seen in the distance.
